WORK REPORT

Customer : UTE Andasol III

Project : Restoring grout on
footings of a HTF tank

Equipment: 31WTE22 BB001 VESSEL
400 m³

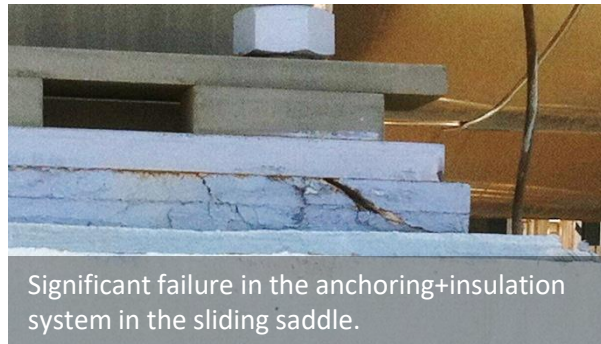
Significant failure in the anchoring+insulation system in the sliding saddle.

The anchoring+insulation system used for the moving supports is thoroughly deteriorated. The insulation part was designed and built using two different materials, two insulation plates and one cement grout which add up to approximately 110mm in thickness.

Any good cementitious grout upholds a shear stress resistance within the adhesion surface of 1.75 MPa, supposed ideal conditions (which slightly differ from in as built conditions). This shear forces, together with a laminated disposition installed without any bonding agent and the loose anchor bolts, was enough to induce a progressive cracking on the isolating material.

The steel plate and the isolation layers moved conjointly. This fact added dynamic friction to the crack party, degrading further and faster the isolating material.

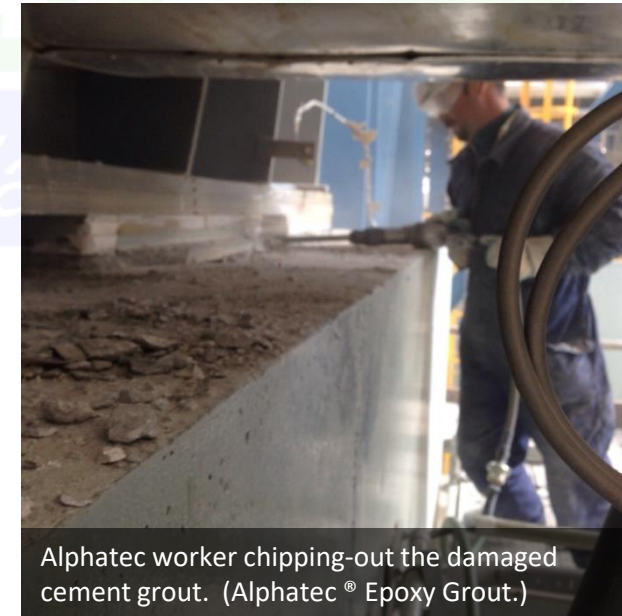
Alphatec worker chipping-out the damaged cement grout. (Alphatec® Epoxy Grout.)

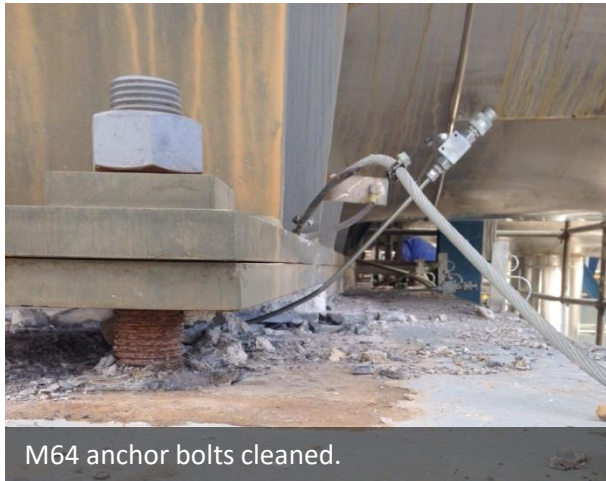
M64 anchor bolts cleaned.

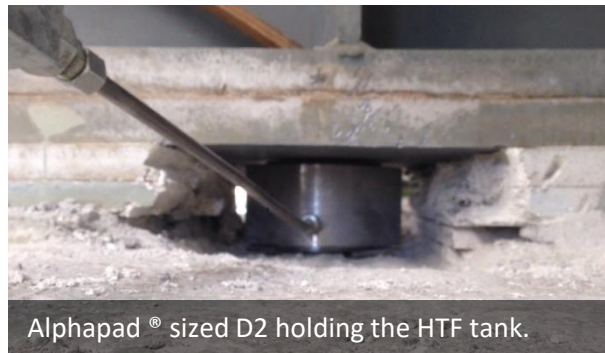
Alphapad[®] sized D2 holding the HTF tank.

Using pneumatic chippers, we got rid of enough material from underneath the sliding plate to be able to place the first Alphapad® sized D2.

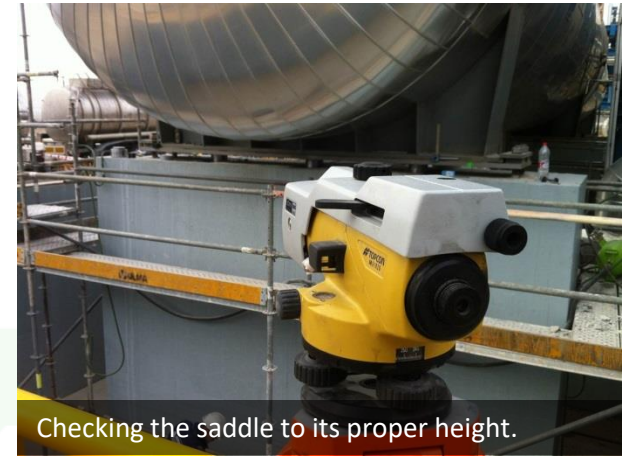
Checking the saddle to its proper height.

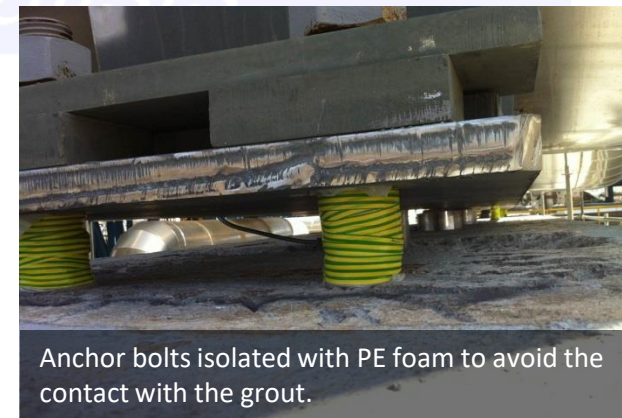
Anchor bolts isolated with PE foam to avoid the contact with the grout.

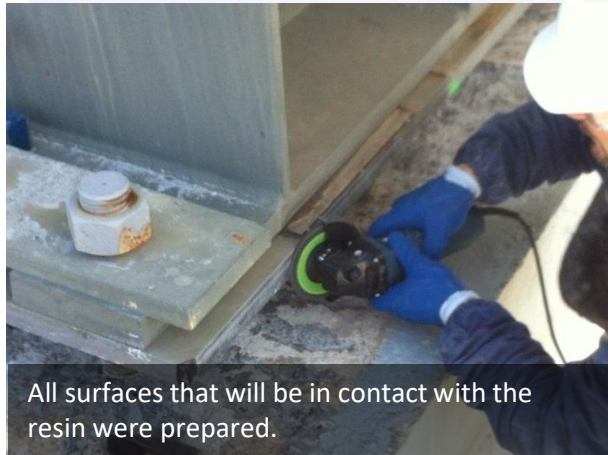
All surfaces that will be in contact with the resin were prepared.

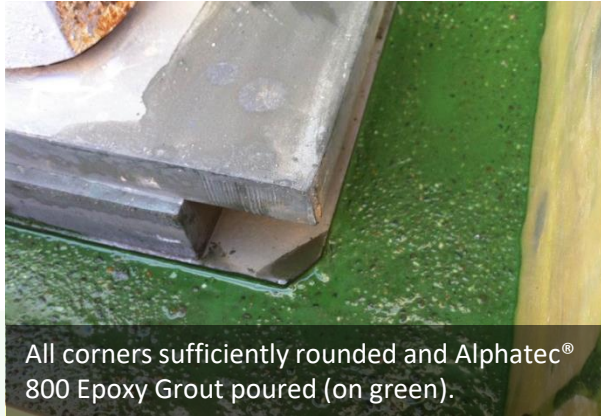
All corners sufficiently rounded and Alphatec® 800 Epoxy Grout poured (on green).

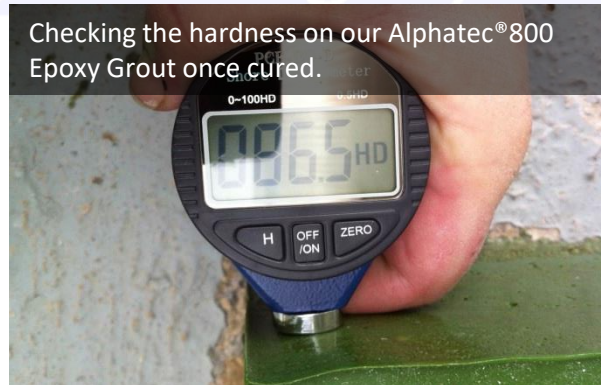
Checking the hardness on our Alphatec® 800 Epoxy Grout once cured.

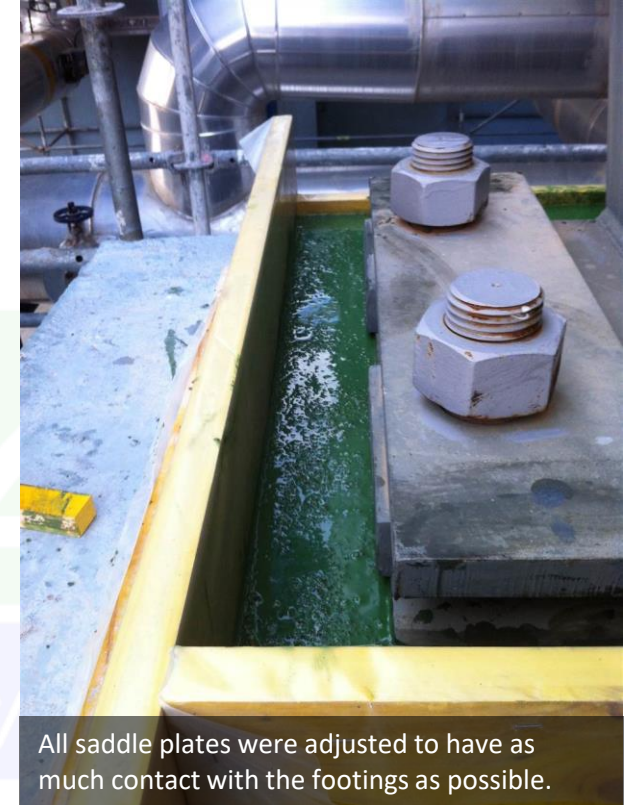
All saddle plates were adjusted to have as much contact with the footings as possible.

Finishing of all grouted areas was revised to avoid sharp edges and After taking off the pressure on the Alphapads®, the whole of the tank weight rested on the epoxy grout.
